Manhole Inspection Summary

Manhole # S17G__028MH

Insp Date: **1/26/09 9:20 AM**

Location Address: **2342 VINE-FAYETT**

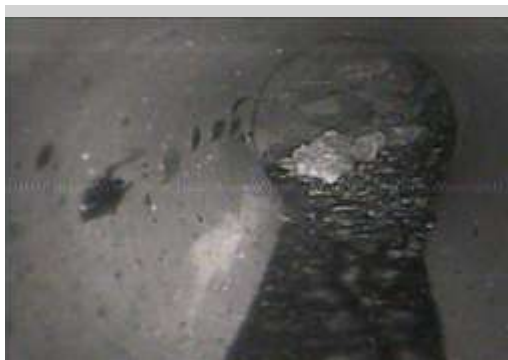
inside view of i5, pipe is collapsed

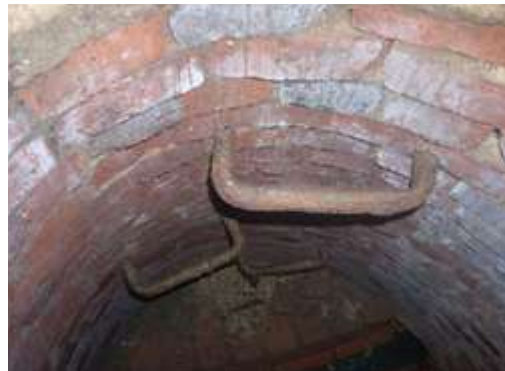
Defect 3

Steps Count: **3** Missing: **0** ☒ **Corroded**

CORRODED STEPS

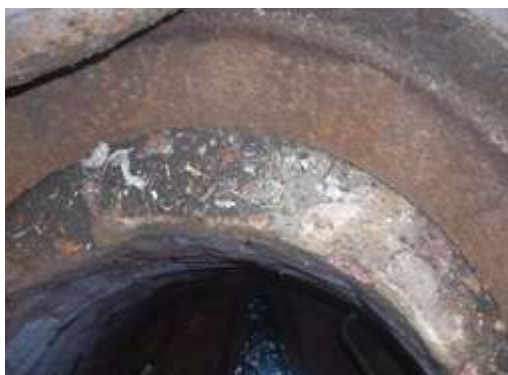
Defect 1

Frame Offset: **3** (in.) Condition: ☒ Sound ☐ Cracked ☐ Leaks

FRAME OFFSET

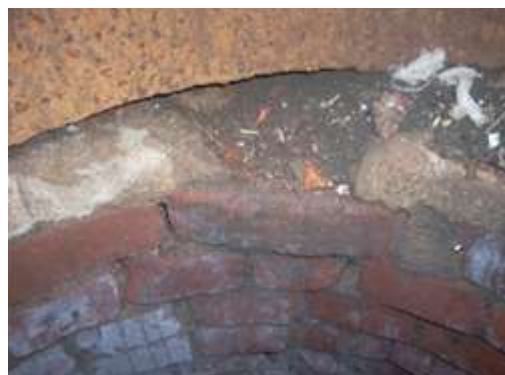
Defect 2

Condition: ☐ Sound ☐ Cracked ☐ Root Intrusion ☐ Loose Brick ☒ **Deteriorated**

DETERIORATED CHIMNEY

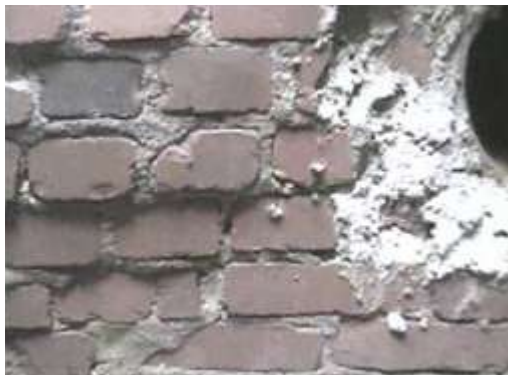
Defect 4

MORTAR MISSING IN SOME AREAS,
DETERIORATION OF BRICK AROUND
PIPE CONNECTION.

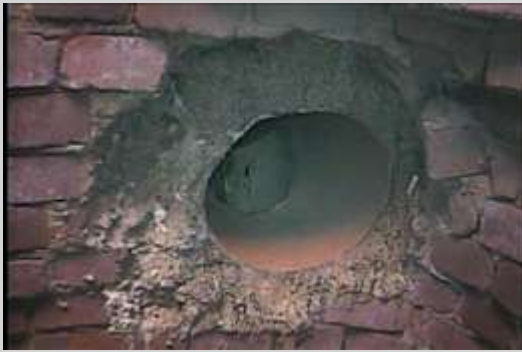
DETERIORATION OF BARREL AROUND THE PIPE

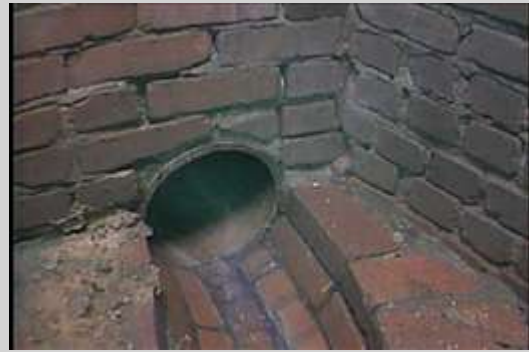
DETERIORATION OF BARREL AROUND THE PIPE
